Operating Experience Weekly Summary 97-41

October 3 through October 9, 1997

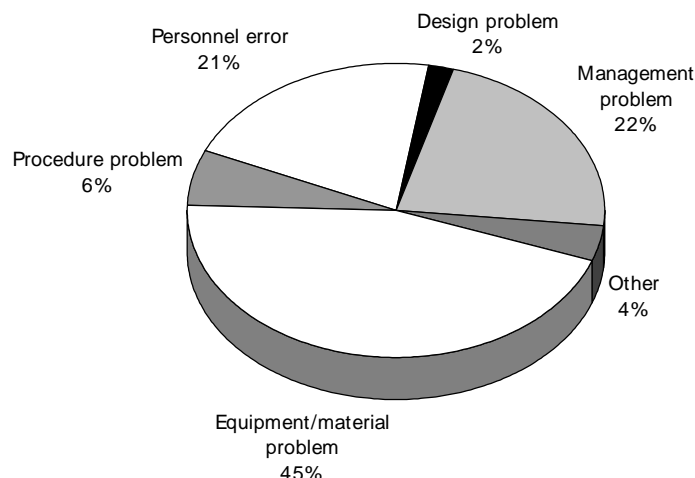
Figure 2-1. Distribution of Direct Causes for Torn Glovebox Gloves¹

OEAF engineers reviewed the ORPS database and found 331 torn glovebox glove events. Figure 2-1 shows the distribution of direct causes for these events. Equipment/material problems represented 45 percent of the direct causes; management problems accounted for 22 percent; and personnel error accounted for 21 percent. Defective or failed material accounted for 80 percent of the equipment/material problems; inadequate administrative control accounted for 68 percent of the management problems; and other human error accounted for 68 percent of the personnel errors.

These events illustrate the importance of performing thorough inspections of glovebox gloves before using them. OEAF engineers contacted two glovebox glove manufacturers. According to the manufacturers, the service life of gloves typically used for radiological protection in glovebox applications is dependent upon several factors. These factors include glovebox environment, types and physical characteristics of the materials being handled, exposure to chemicals or cleaning agents, and the physical degree of the work being performed. Facility managers should ensure that their procedures require a thorough inspection of gloves before each use, and they should emphasize to the workers the importance of performing these inspections.
